# New Hampshire Volunteer Lake Assessment Program

## 2003 Interim Report for Deering Lake Deering

NHDES  
Water Division  
Watershed Management Bureau  
29 Hazen Drive  
Concord, NH 03301

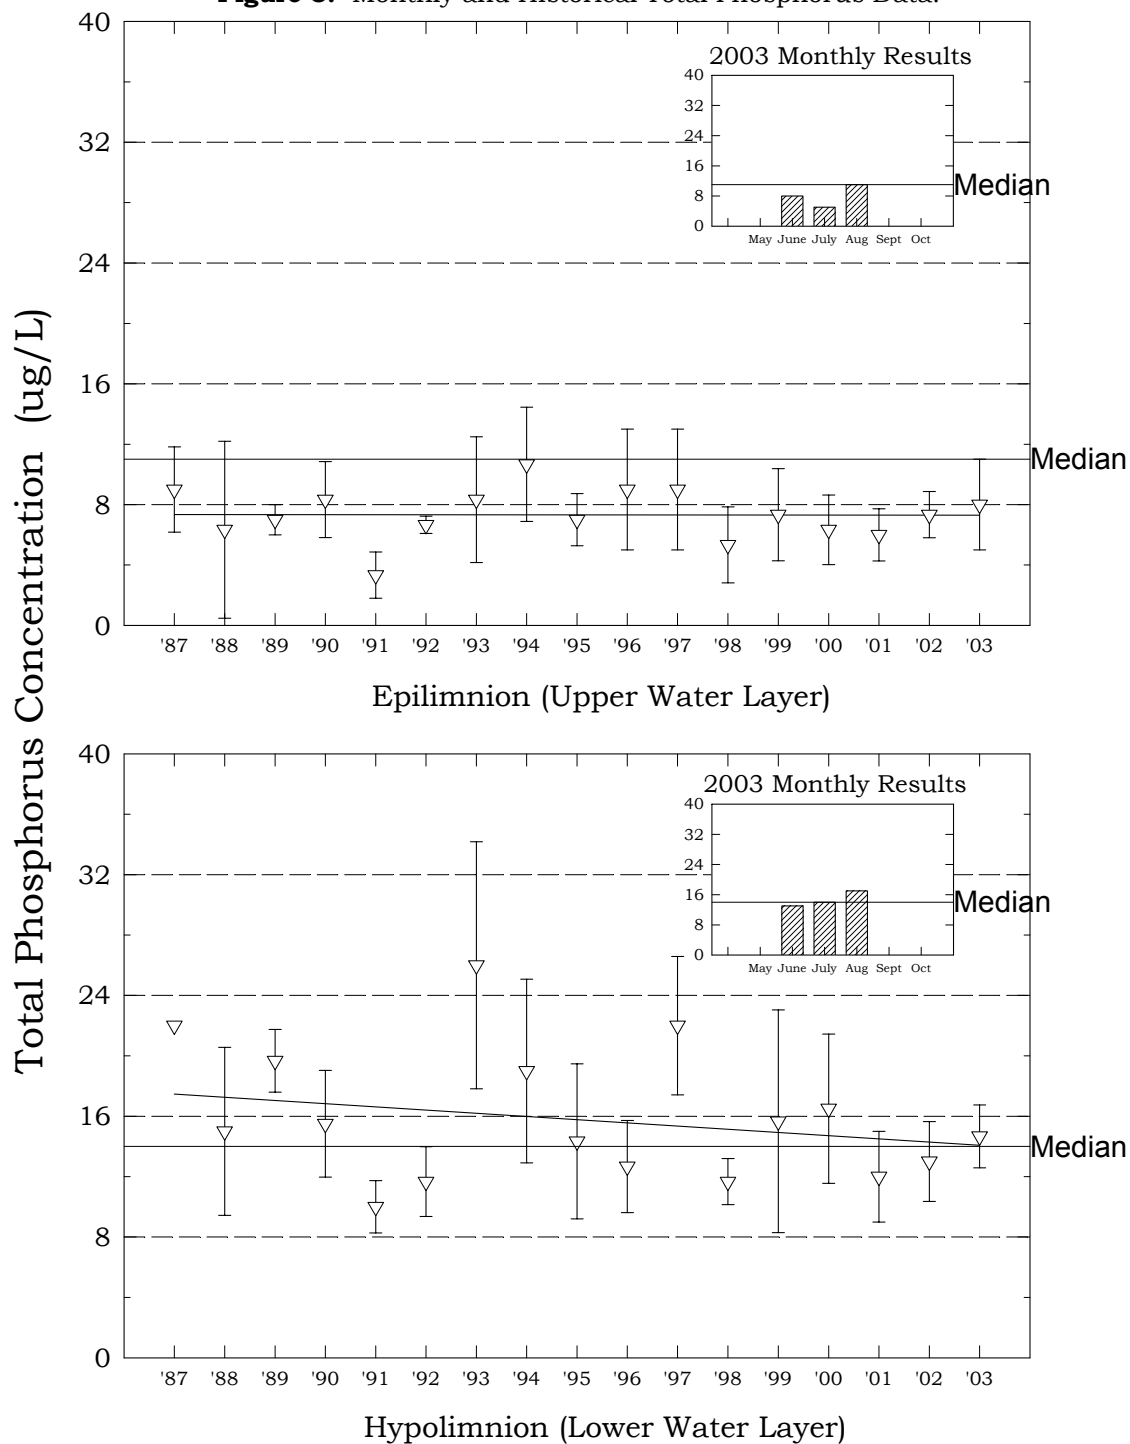
**Figure 3.** Monthly and Historical Total Phosphorus Data.

- **Figure 3 and Table 8:** The graphs in Figure 3 (Appendix A) show the amounts of phosphorus in the epilimnion (the upper layer) and the hypolimnion (the lower layer); the inset graphs show current year data. Table 8 (Appendix B) lists the annual maximum, minimum, and median concentration for each deep spot layer and each tributary since the lake/pond has joined the program.

The current year data for the epilimnion (the top inset graph) show that the phosphorus concentration **decreased** from June to July, and then **increased** from July to August. The phosphorus concentration in June and July was **less than** the state median, while the concentration in August was **equal to** the state median.

The historical data show that the 2003 mean epilimnetic phosphorus concentration is **less than** the state median.

The current year data for the hypolimnion (the bottom inset graph) show that the phosphorus concentration **increased gradually** from June to August. The phosphorus concentration in June was **slightly less than** the state median, in July it was **equal to** the state median, and in August it was **slightly greater than** the state median.

The historical data show that the 2003 mean hypolimnetic phosphorus concentration is **approximately equal to** the state median.

Overall, visual inspection of the historical data trend line for the epilimnion and hypolimnion show **a variable** phosphorus trend, which means that the concentration has **fluctuated**, but has *not continually increased or decreased* since monitoring began.

One of the most important approaches to reducing phosphorus loading to a waterbody is to continually educate watershed residents about its sources and how excessive amounts can adversely impact the ecology and value of lakes and ponds. Phosphorus sources within a lake or pond's watershed typically include septic systems, animal waste, lawn fertilizer, road and construction erosion, and natural wetlands.
